| <div data-bbox="243 1205 389 1247">AGENDA</div> <div data-bbox="1317 1190 1421 1262"></div> |
|---|
| <div data-bbox="271 1329 972 1377"><b>Facility Assessments: High Level Review</b></div> <ul data-bbox="321 1419 854 1734" style="list-style-type: none"><li>• Carlton High / Middle School</li><li>• South Terrace Elementary</li><li>• Wrenshall K-12 School</li><li>• Next Steps</li></ul> |

## CARLTON MS/HS

## SOUTH TERRACE ELEMENTARY & ATHLETICS

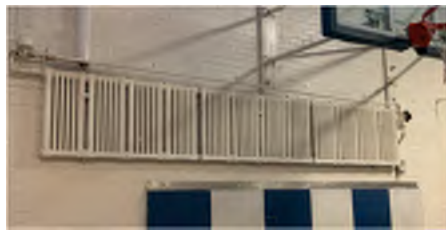
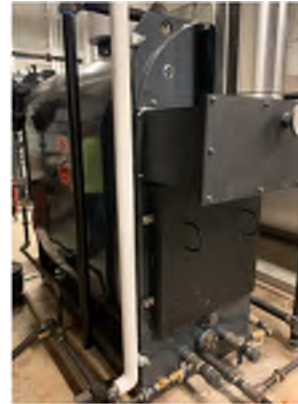
**Mechanical (Heating):**

- Steam heating (coils and radiation)
- 1 brand new steam boiler, one original
- Newer (2020) domestic hot water heater
- Original steam distribution piping

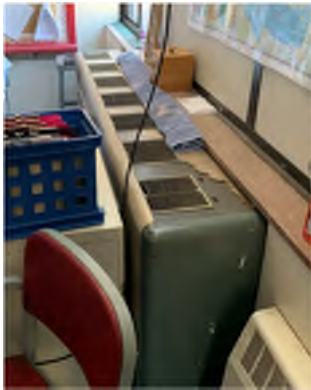
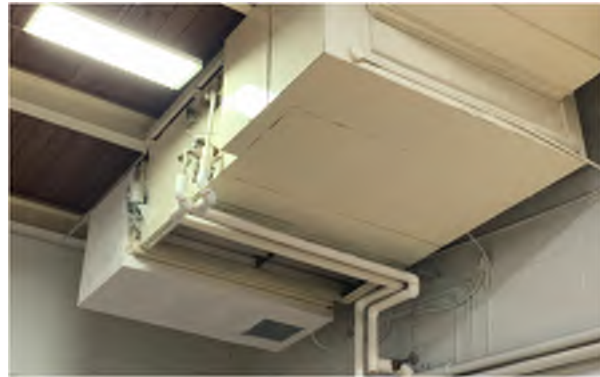
**Mechanical:**

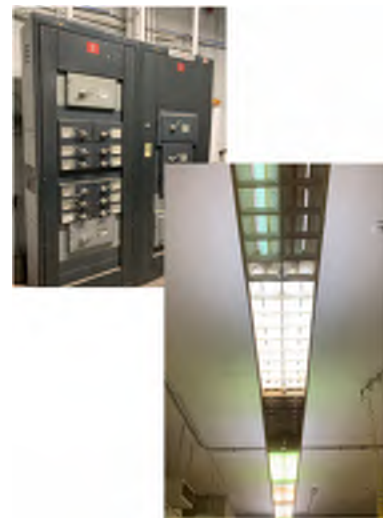
**Electrical:**

- Main electrical panels original to age of building (1950's, 60's)
- Minimal upgrades besides extending wiring for additional outlets as needed
- Lighting is older technology T8 and T12 fluorescent fixtures

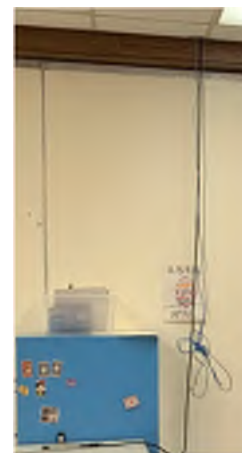
**Technology:**

- Exposed Cabling
- Holes cut in ceilings
- Loose cables

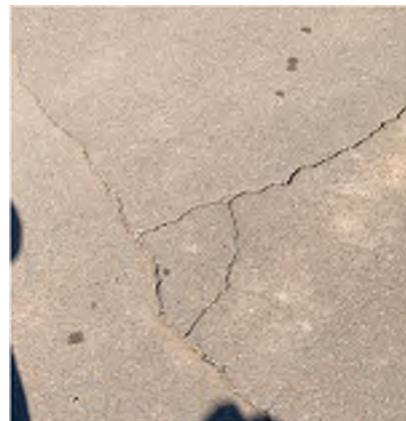
**Site:**

- Parking lot was replaced not too long ago, but is beginning to crack
- Sealing of cracks and sealcoating is needed to increase the life expectancy
- No play equipment

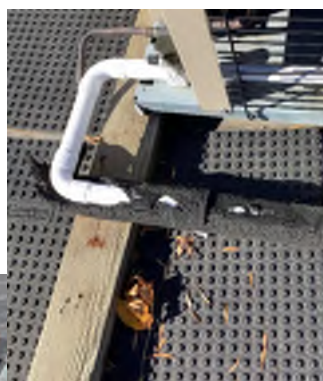
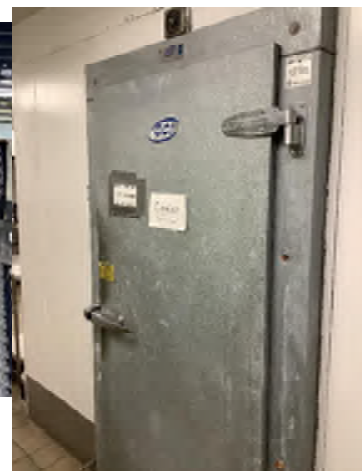
- New Kitchen Cooler & Freezer
- New PA / Clock System
- Security Updates
  - 20 Camera's
  - 6 FOB's – Exterior Doors

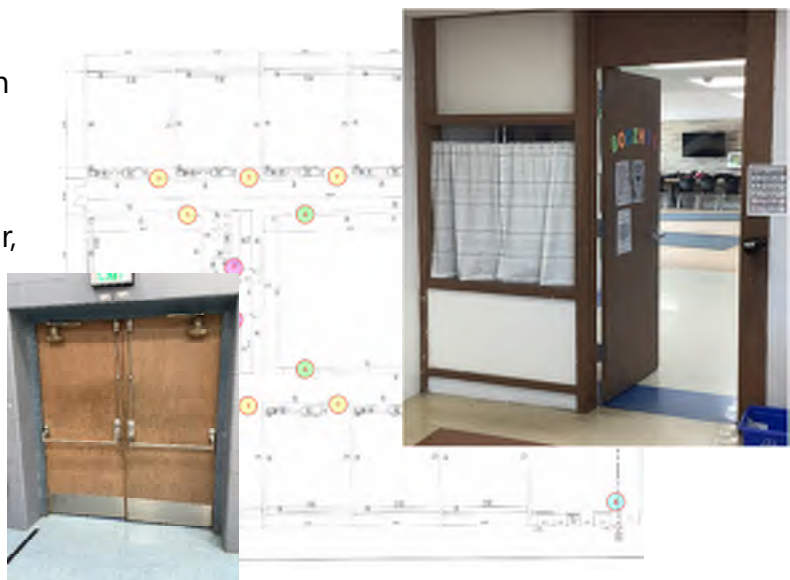
### **Existing:**

- Original wood doors with wood frames

### **Proposed Scope:**

- Remove and replace door, frame, side section and hardware

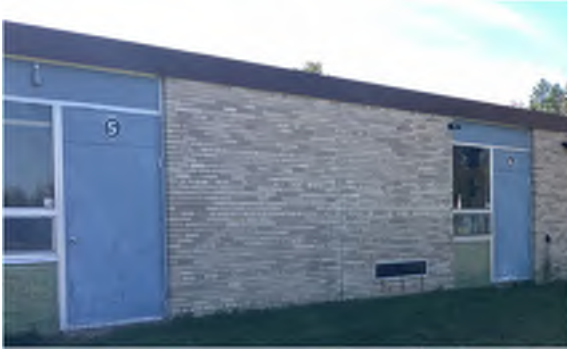
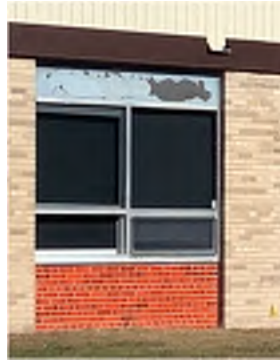
- Replace Windows:
  - Includes areas above/below windows
- Replace 4 doors with window
- Spot tuckpointing and caulking repairs

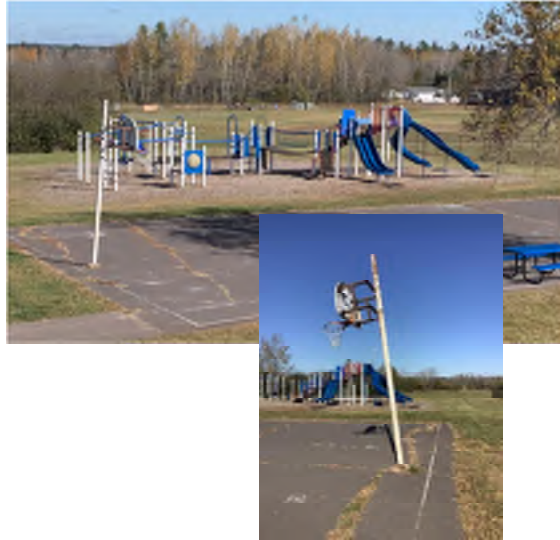
### **Existing:**

- Old Equipment
- ADA concerns

### **Proposed Scope:**

- New Equipment
- Poured in place surfaces
- Accessible routes
- New paved basketball court

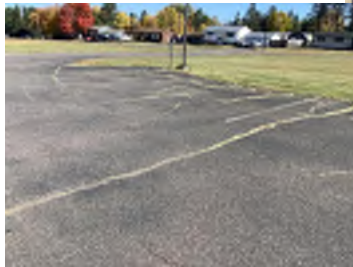
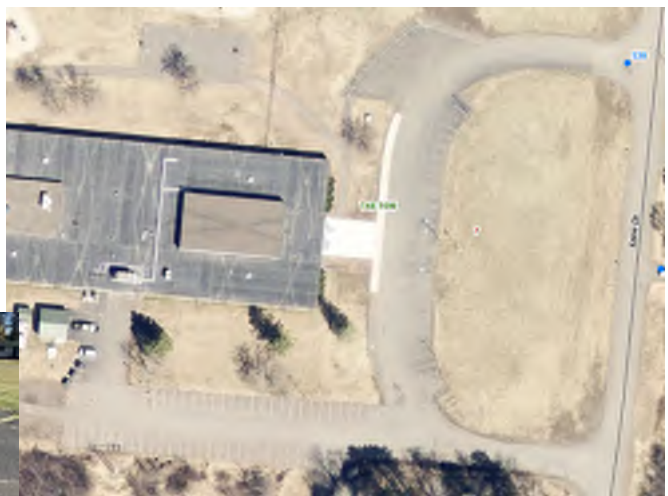
### **Existing:**

- Safety concerns with current setup
- Need for additional parking
- Some paving in need of repair or replacement

### Proposed Scope:

- Separate Bus pickup/drop-off from Parent pickup/drop-off
- More Parking (~80 new spaces and 6 accessible spaces)
- Plan for 9 busses and 100 parent drop-offs

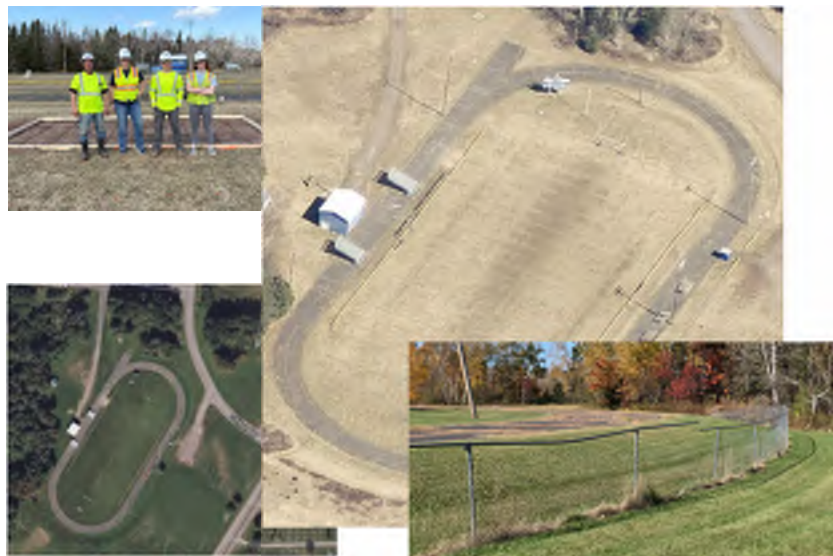
- New accessible bleachers
- Accessible routes
- New LED lighting & poles
- New Scoreboard
- New fence
- Irrigation system
- New Track
- Gravel Parking Lot

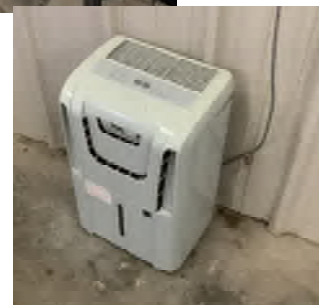
The two CTE classrooms and a lower-level IT closet house computers and servers and the spaces are warm.

Install cooling for comfort and to protect and increase longevity of the equipment.

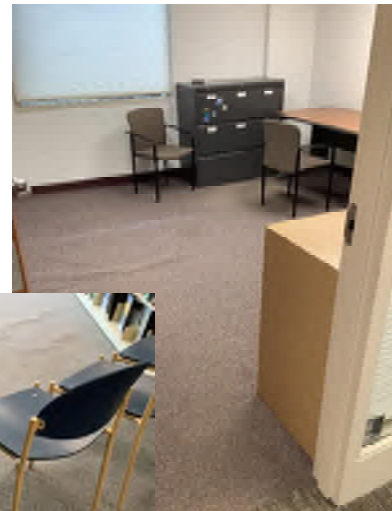
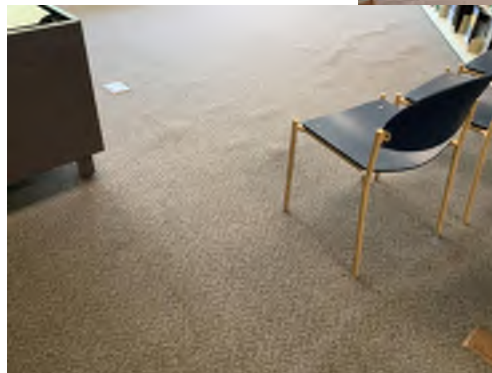
The Media Center and the center office area have older carpeting.

Replace old carpeting with new carpet squares.

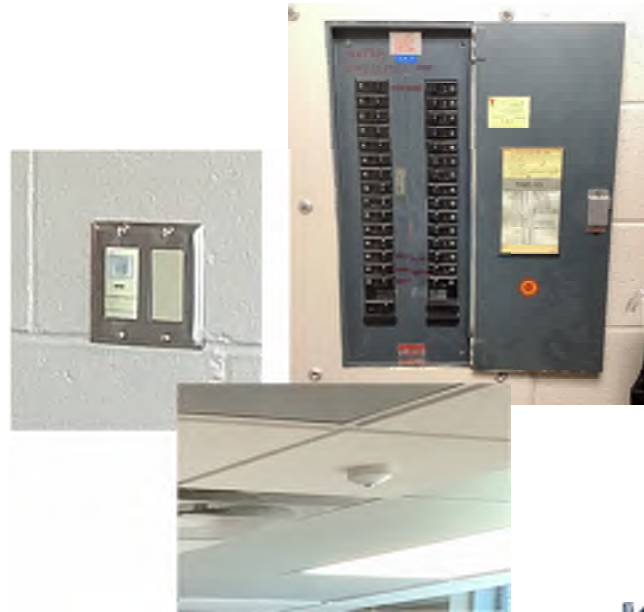
Occupancy sensors are no longer working in several locations. A few very old electrical panels are still in use.

Replace failing lighting sensors/controls and replace outdated panels.

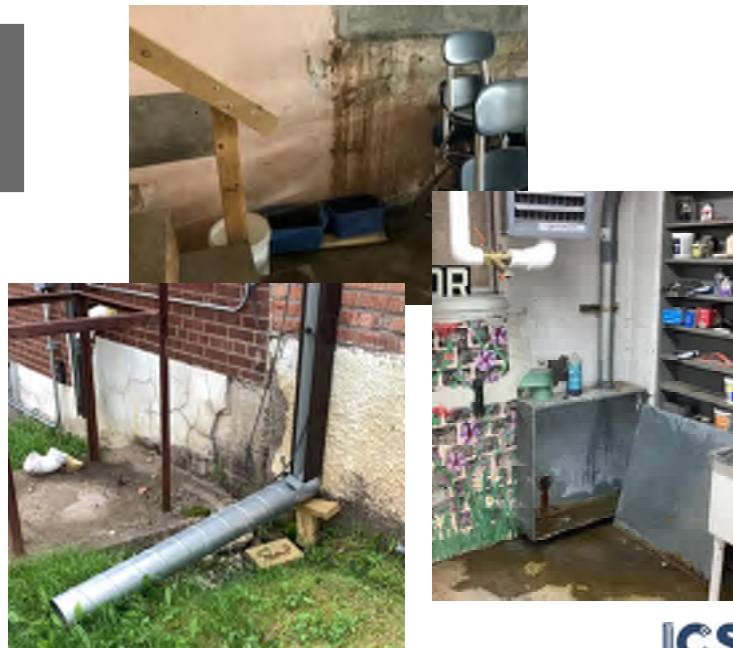
The North side of the building is experiencing water infiltration on the lower level. Combination of drainage and existing conditions are contributing to the problem.

Install proper drainage for downspouts and landscape as needed. Dig up and remove and old electrical conduit (repair wall).

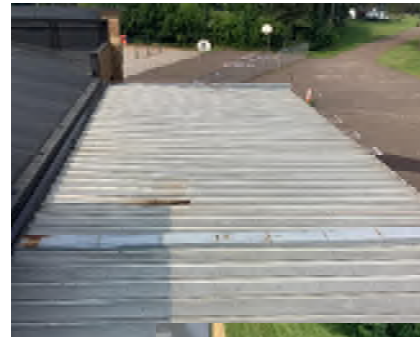
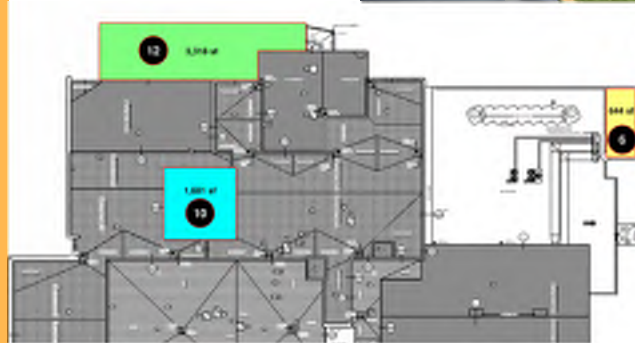
There are three (3) roof sections at the school and the bus garage that are beyond life expectancy. Ladders between roofs are old and there is no safe access to the old pool roof.

Replace the bus garage and sections 6 and 10 with new EPDM roofing. Replace metal roof (section 12) with a new metal roof. Update ladders and add ladder access to (old pool) roof.

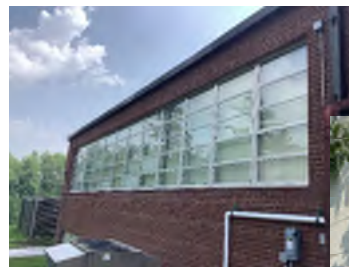
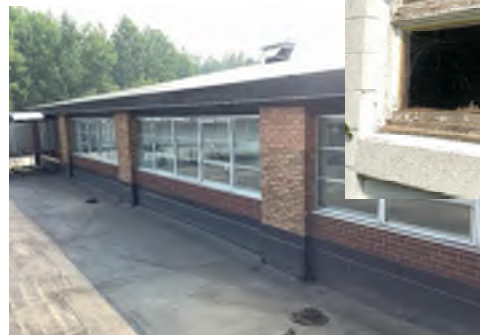
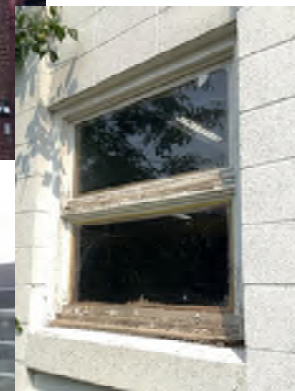
There are a few areas of very old window sections. The 1999 windows are now 26 years old. Bus garage has very old windows.

Remove and replace windows.

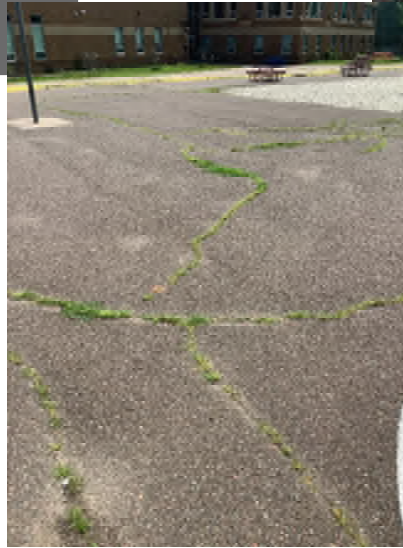
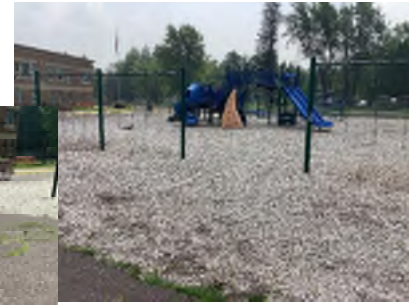
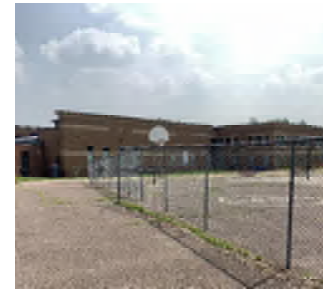
The playground equipment is newer, but the woodchips (ADA), fencing and paved area is in poor condition.

Replace woodchips with a poured in place surface.  
Replace the paved (asphalt) play surfaces.  
Install new fencing.

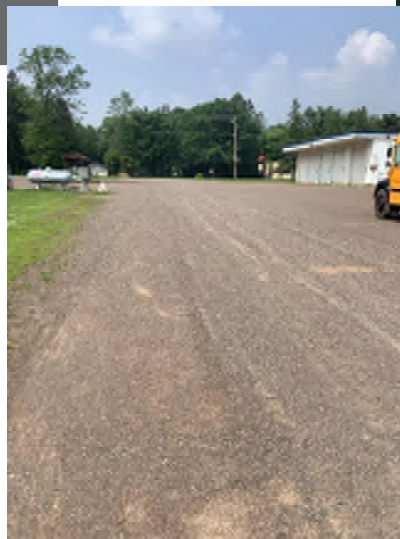
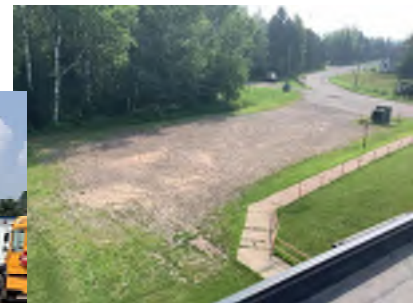
There are dirt areas (East parking & Bus garage area) that could be paved. There are also paving repair and maintenance needed in existing paved areas.

Replace dirt areas with asphalt.  
Repair bus loop paving.  
Patch, sealcoat and restripe the newer parking lot.

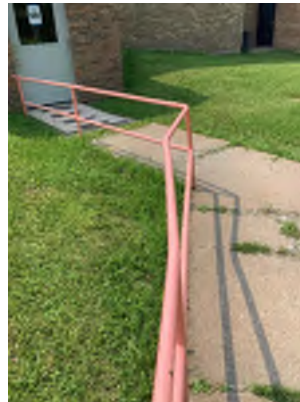
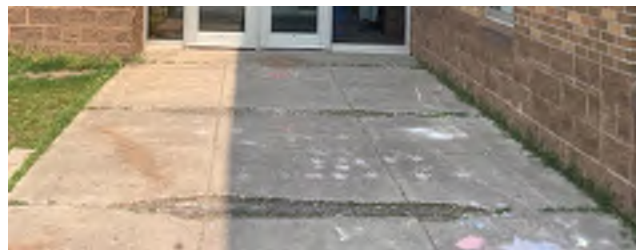
Several areas of concrete sidewalks are damaged and there are some older steel railings.

Repair and replace damage sections of concrete and replace railings with aluminum style.

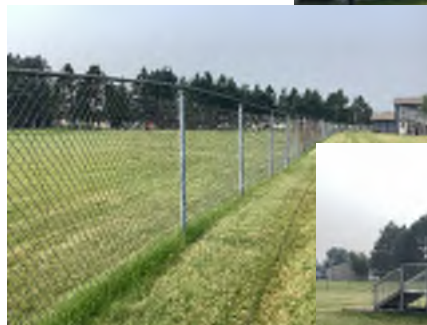
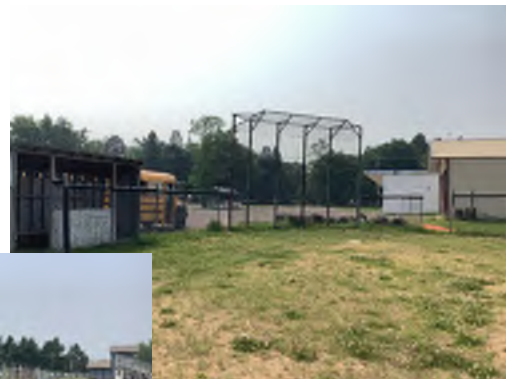
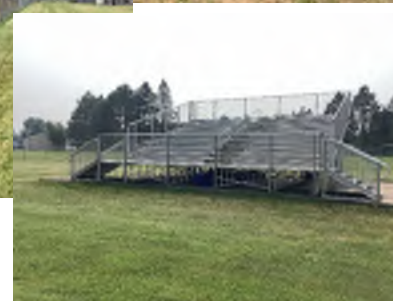
Rundown baseball/softball area.  
Poor fencing.  
Bleachers are not accessible.  
No accessible pathways.

Repair and replace fencing.  
Update areas for accessibility.

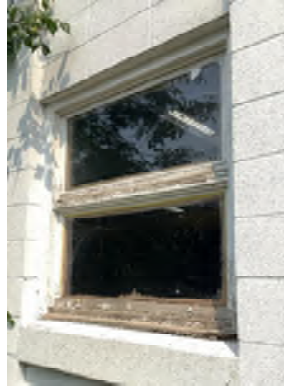
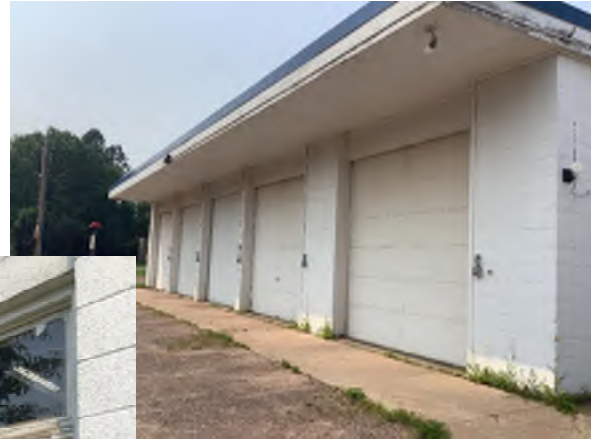
The bus garage is from 1962. The roof, several windows and garage doors need replacement.

Replace the roof, older windows and garage doors.
